**Flood Control Project Maintenance
Levee Inspections**

Fall 2010 Levee Maintenance Deficiency Summary Report

Madera County FCWCA

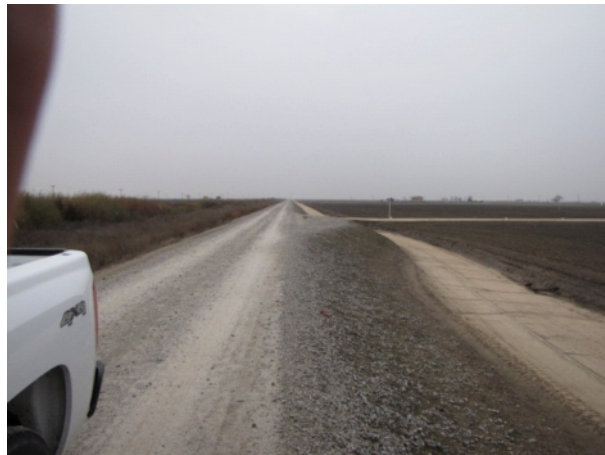
phillips_f_20101129_328.jpg

Levee Mile Report Line	9
Start Levee Mile	2.50
End Levee Mile	6.06
Location	Land Side
Category	Earthen Levee
Item	Vegetation
